Section 219
Environmental Infrastructure Investigation

Inflow/Infiltration and Sewer System Evaluation Study

Epping, New Hampshire

October 1996

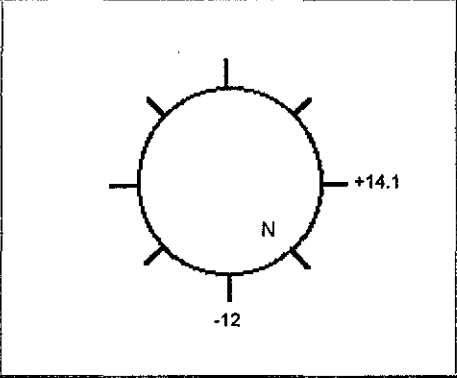
212 FT to MH No.: 12
Buried: No
Grade: AT
Drainage Area: (SQFT)
8 X 8 = 57.60
Runoff Coefficient: 0.9
Steps: NONE

Pickhole(s):	2	1	Inch.
Liftheole(s):	0	0	Inch
Surcharge From Invert:			
NONE EVIDENT			
Currently:			Feet
Marks To:			Feet
Comments:			
OUTGOING PIPE CONNECTION LEAK FROM 6-10:00 POSITIONS, 1.5 GPM

ITEM	MATERIAL	CONDITION	LEAK (GPM)	DEFECTS
FRAME	CAST	GOOD		
CORBEL	BRICK	POOR		MISSING MORTAR
WALLS	PRECAST	GOOD		
FLOOR	BRICK	GOOD		
INVERT	BRICK	GOOD

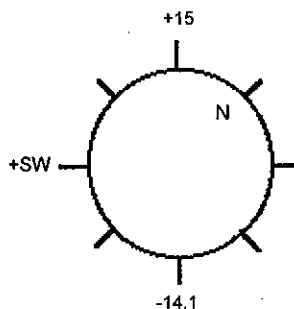
Municipality:	EPPING, N.H.	Inspection Date:	5/28/96
Location:	17 ELM STREET	Sub-System:	E
Manhole No.:	14	Map Number:	E
367 FT to MH No.: 14.1		Pickhole(s):	2 1 Inch.
Buried: No		Lifthole(s):	0 0 Inch
Grade: AT		Surcharge From Invert:	
Drainage Area: (SQFT)		NONE EVIDENT	
3 X 3 = 8.10		Currently:	Feet
Runoff Coefficient: 0.9		Marks To:	Feet
Steps: NONE		Comments:

ITEM	MATERIAL	CONDITION	LEAK (GPD)	DEFECTS
FRAME	CAST	GOOD		
CORBEL	BRICK	POOR		DETERIORATING BRICKS, MISSING MORTAR
WALLS	PRECAST	FAIR		MISSING MORTAR
FLOOR	BRICK	GOOD		
INVERT	BRICK	GOOD
